**NESHAP ASBESTOS SURVEY AND LEAD BASED PAINT
REPORT**

**The Florida's Turnpike Overpass Bridge
FDOT Structure No. 940050**

**Project Development and Environment (PD&E) Study
Midway Road (CR 712) from
Glades Cut Off Road (CR 709) to Selvitz Road (CR 615)
St. Lucie County, Florida**

May 2016

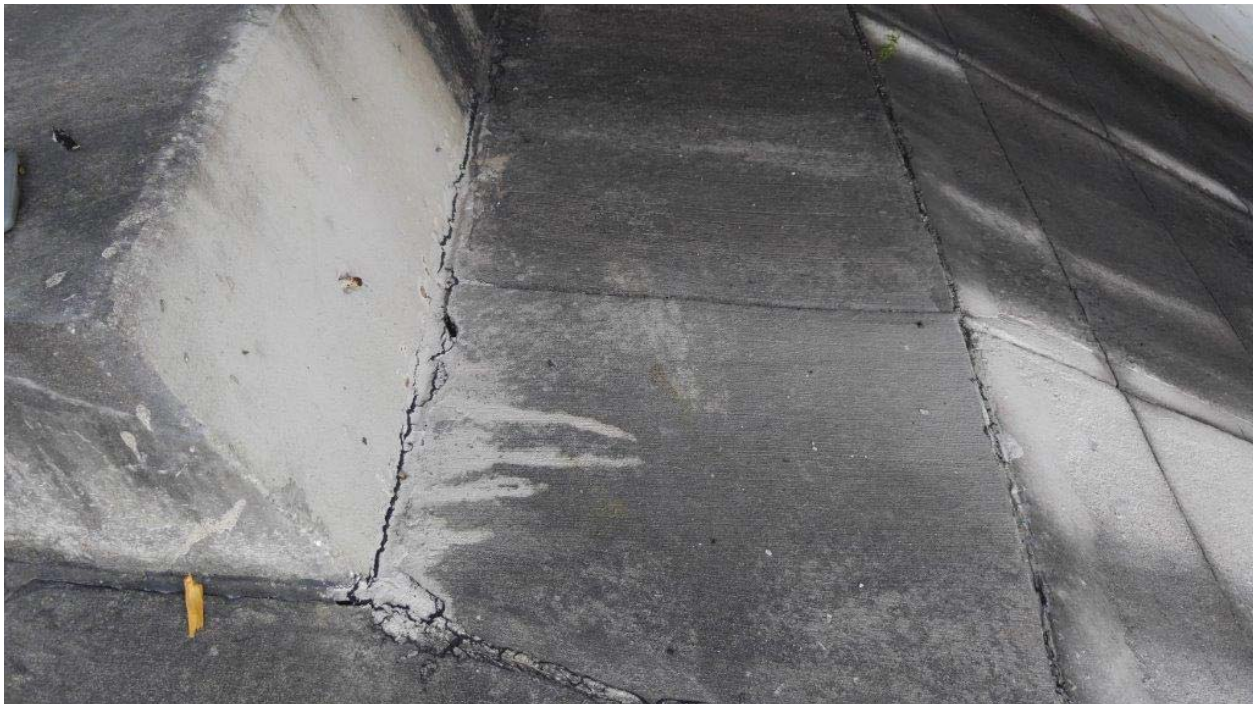
Homogeneous Area 1 – White Painted Caulking retaining wall under deck (samples 1, 2, and 3)

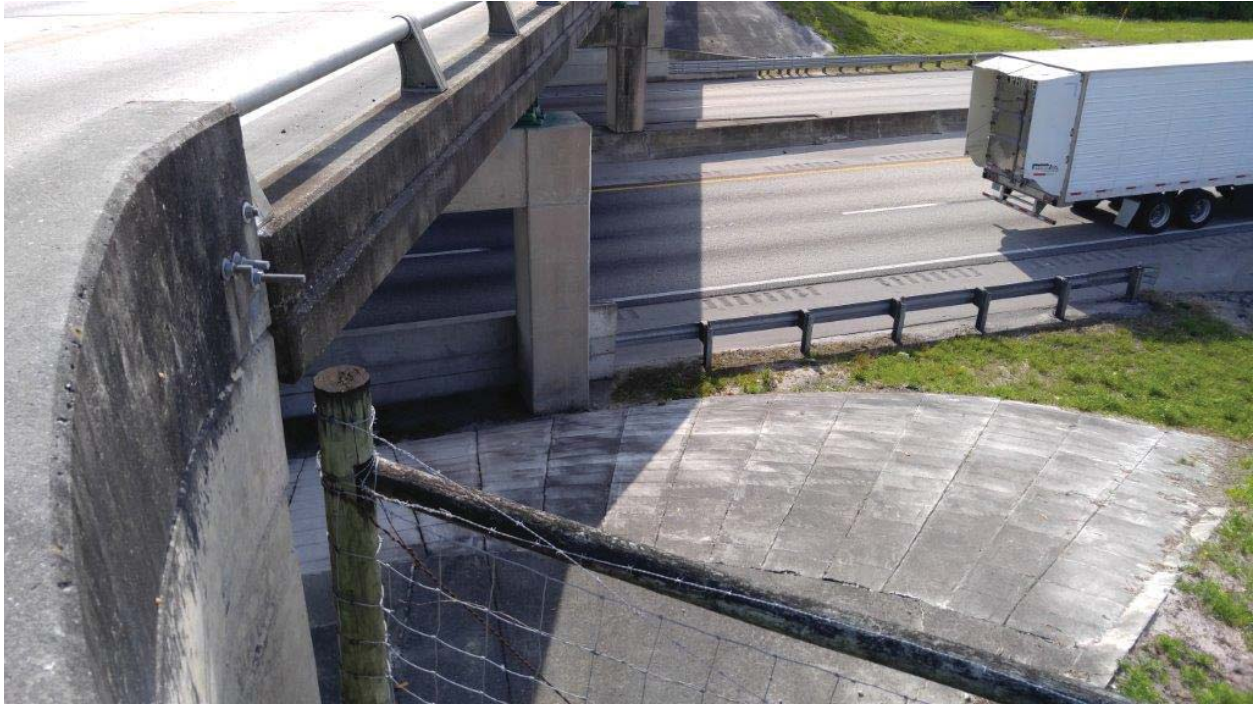
Homogeneous Area #1 White Painted Caulking (samples 1, 2, and 3)

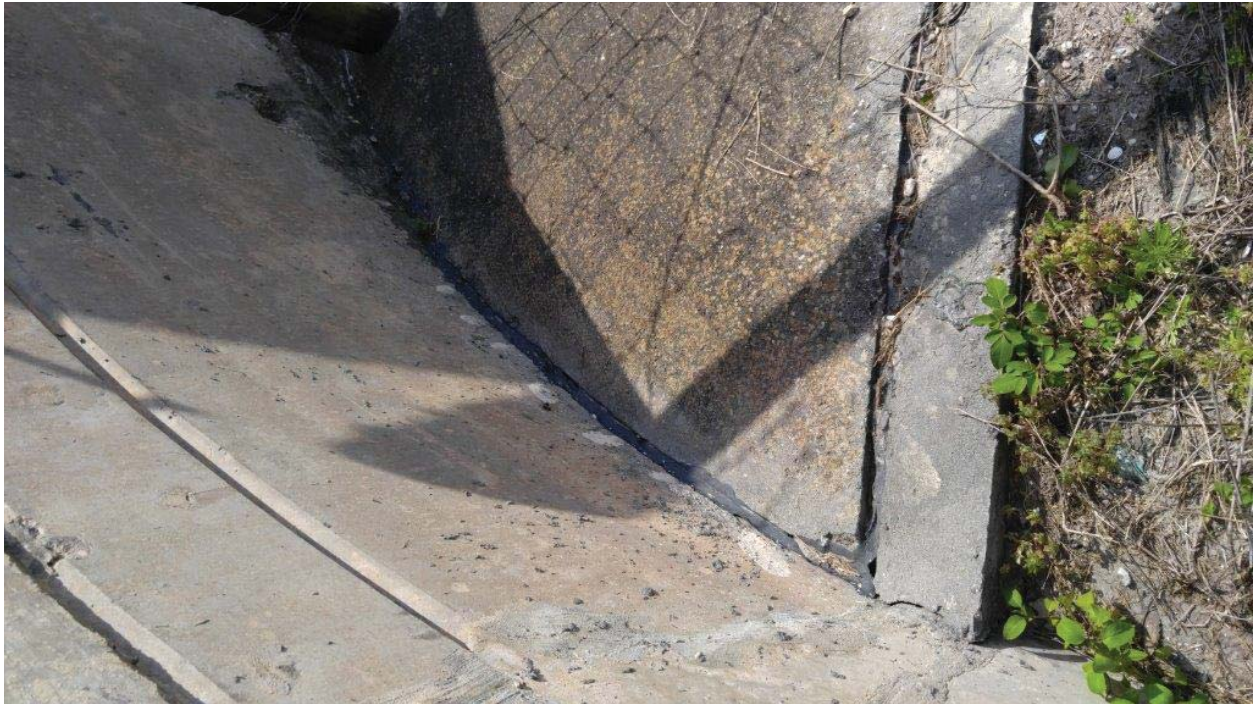
Homogeneous Area 2 – Black joint compound Top Deck (Samples 4, 5, and 6)

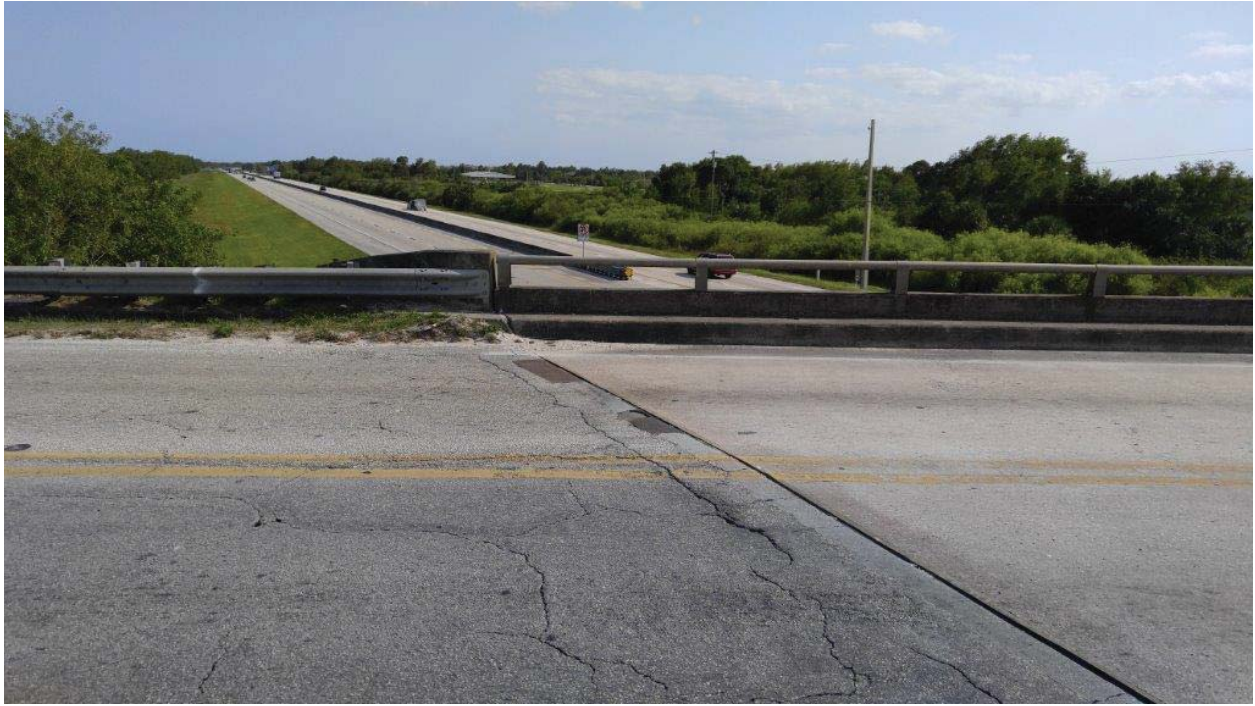
Homogeneous Area 2 – Black joint compound Top Deck (samples 4, 5, and 6)

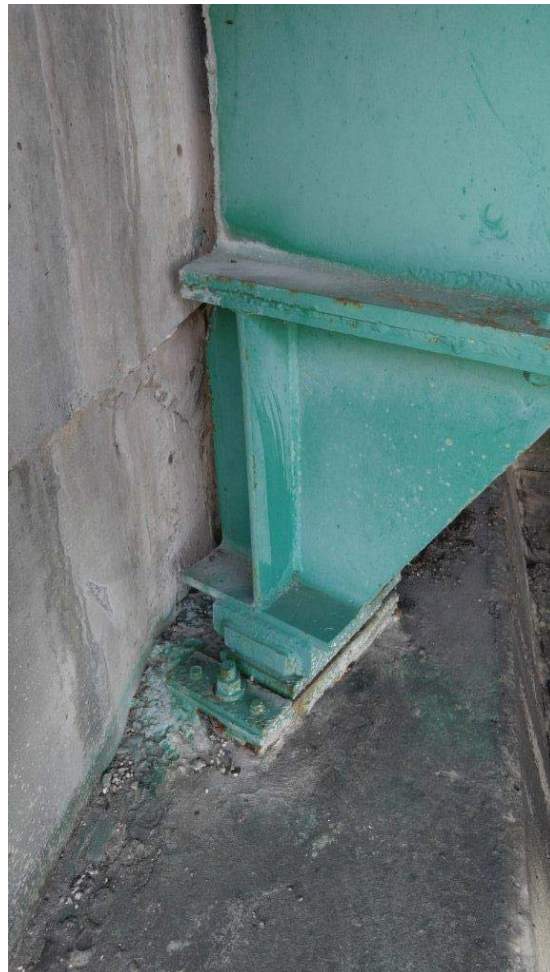
Sample # 7 Concrete – bridge abutment

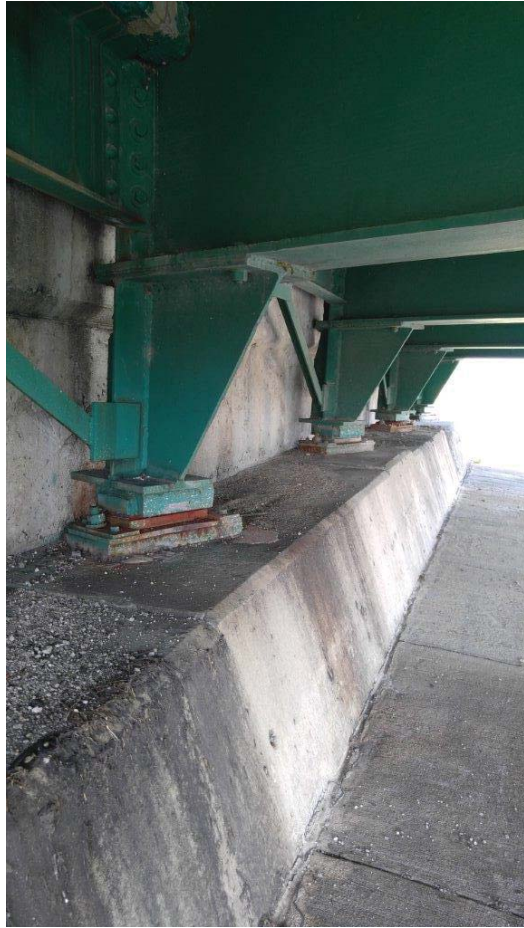
Green Paint under Bridge (LBP Sample #1)

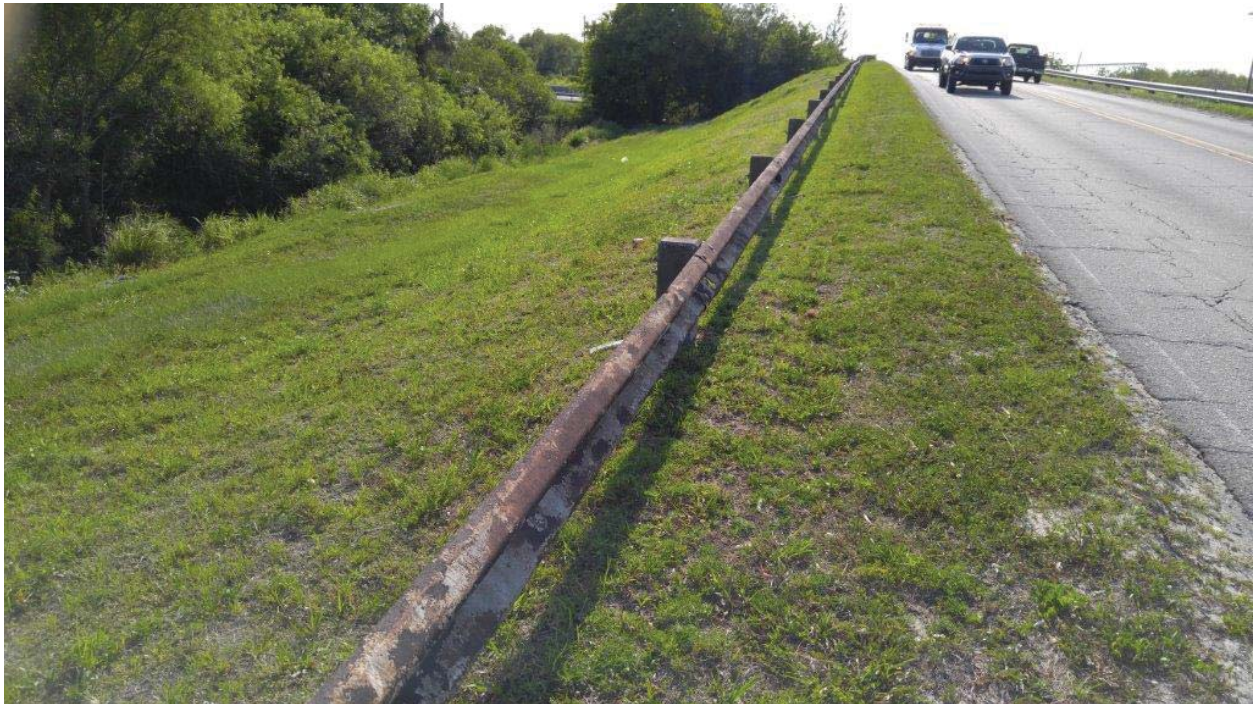
Five samples were collected from the bridge structure. Sample results ranged from 26.4 mg/kg on the painted caulking on retaining wall under the bridge to 14,700 mg/kg on the old guard rail located along the south east portion of the east bound overpass. Based on the results of the testing two of the samples exceed the USEPA definition for LBP of 5,000 ppm.

Guardrail South-East (LBP sample #2)

DPS recommends that the Contractor review the results and formulate a site specific health and safety plan (HASP) in accordance with federal, state and Contractor health and safety policies and abatement procedures. An overview of Lead regulations is discussed in section 5.2 of this report. Should the Contractor dispose of structures with painted surfaces testing and disposal of those materials should be conducted in accordance with the EPA requirements related to Lead Paint disposal. Should the Contractor recycle the structural steel, verify sample requirements if any with the recycling facility. All scrap metals (as defined in Title 40 Code of Federal Regulations (CFR), Part 261.1(c)(6) and (9)) that are generated during the demolition of the structure may be recycled by a permitted recycling company and are exempt from hazardous waste management standards.

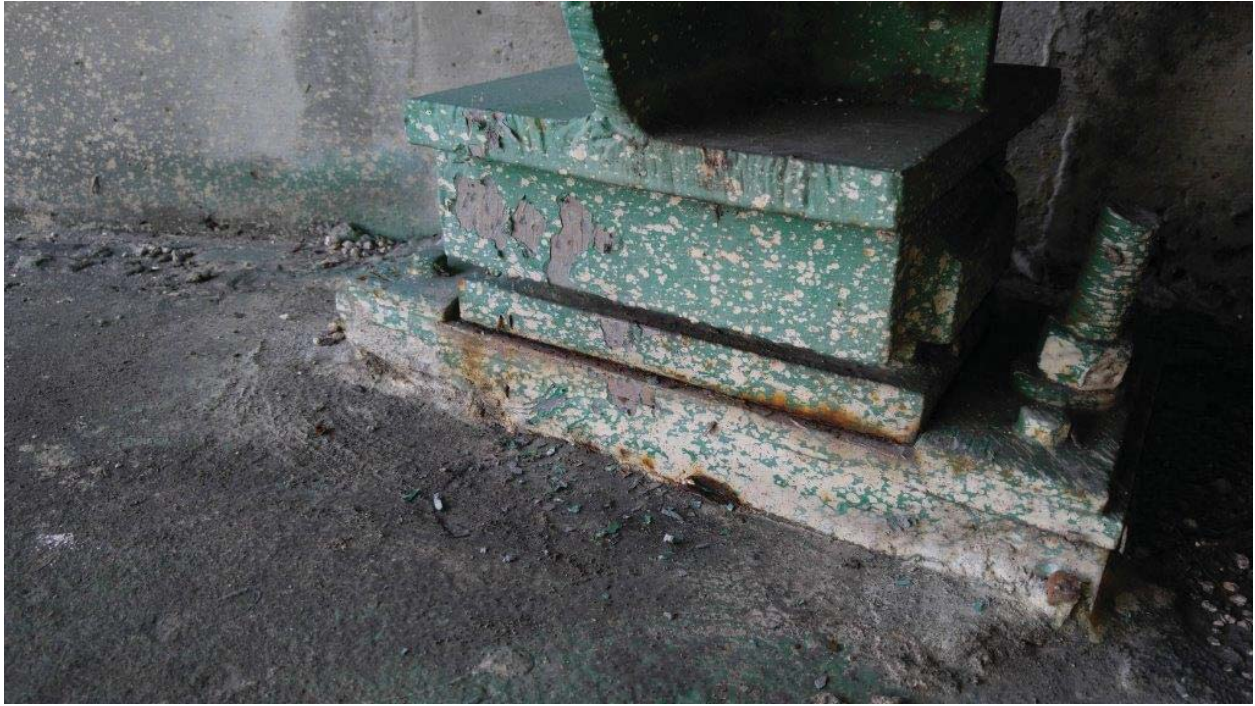
Bridge Paint Southwest (LBP Sample #3)

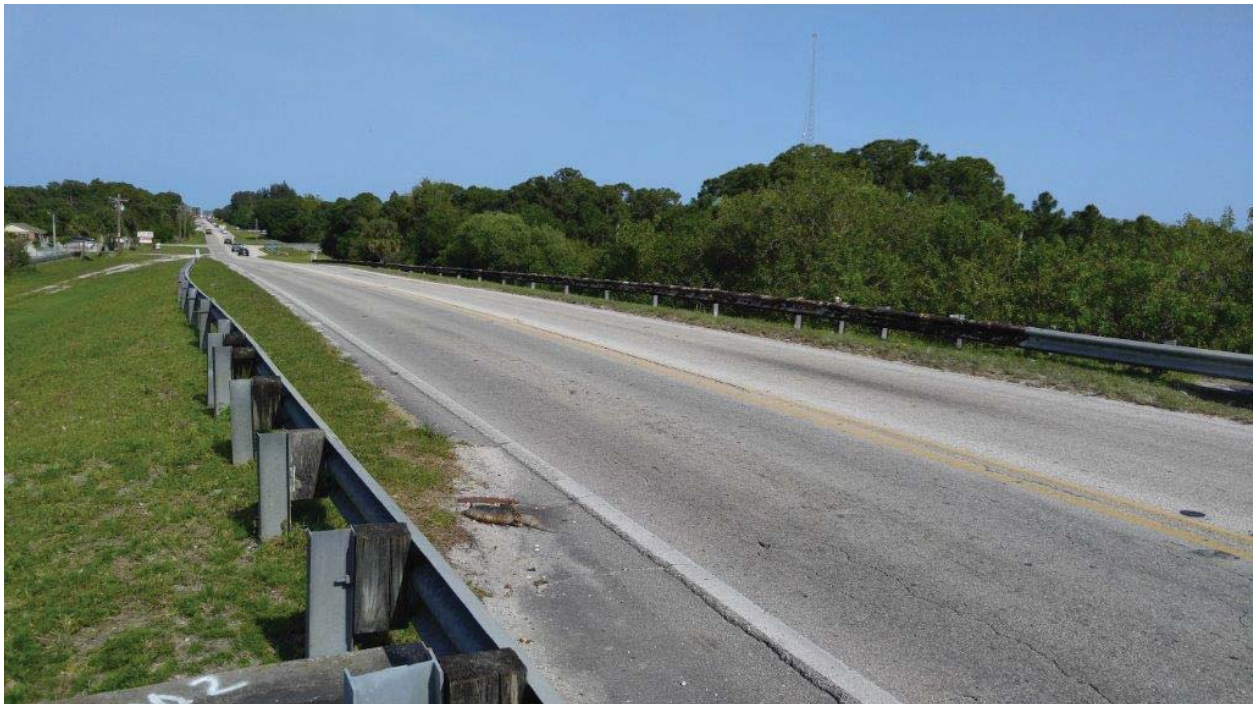
Guardrail near bridge (southeast guardrail) (LPB Sample #4)

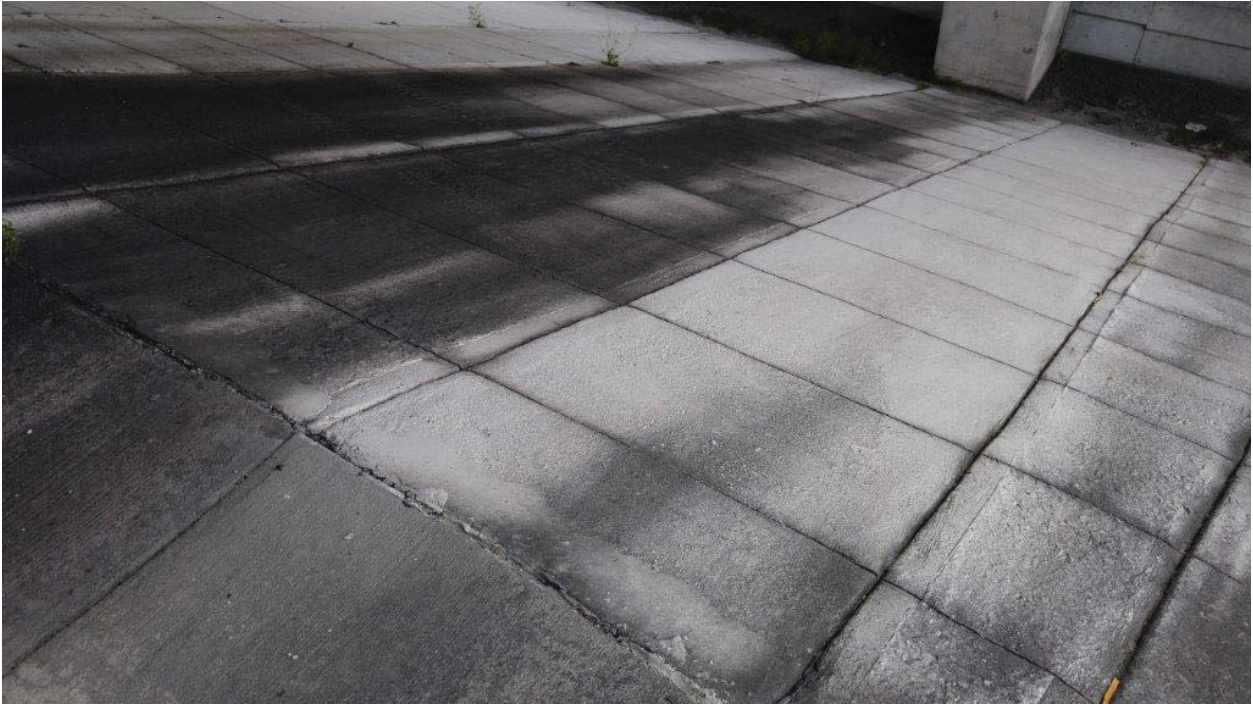
White paint on Caulking under bridge (LBP Sample #5)

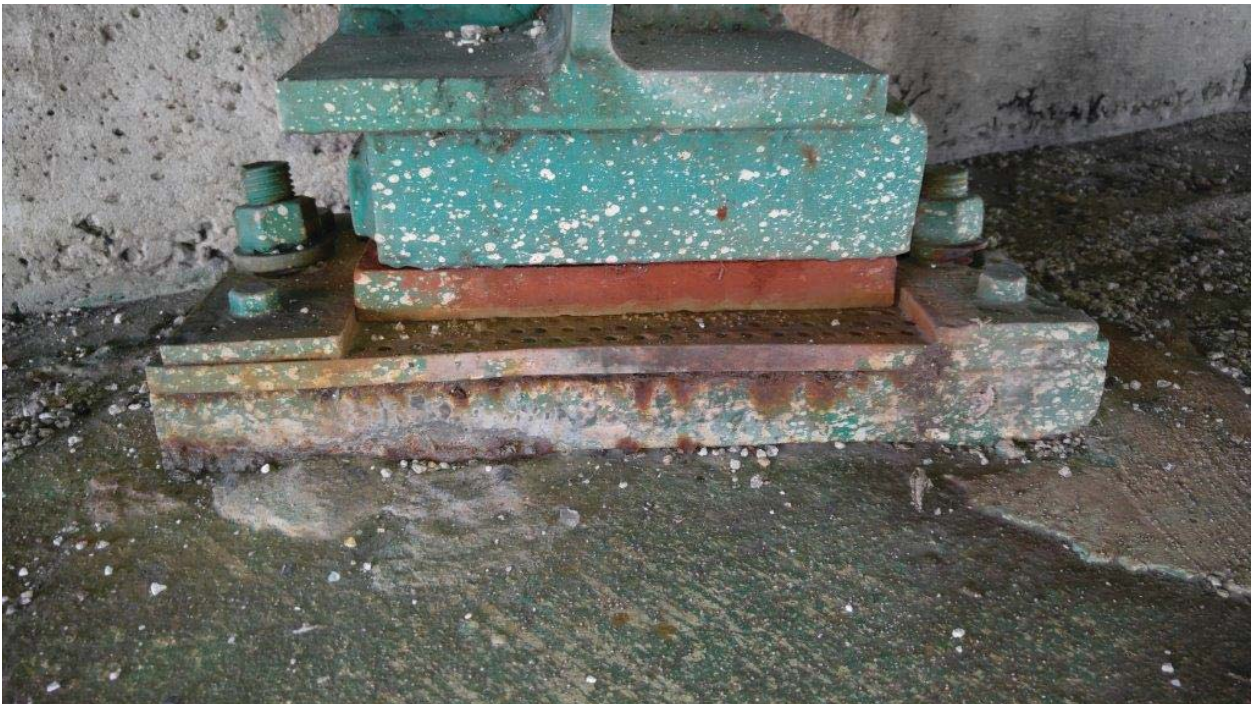
View of bearing pads (all metal)
